DESIGN OF FLEXIBLE AIRFIELD PAVEMENTS FOR  
MULTIPLE-WHEEL LANDING GEAR ASSEMBLIES

TEST SECTION WITH LEAN CLAY SUBGRADE

TECHNICAL MEMORANDUM NO. 3-349

WATERWAYS EXPERIMENT STATION

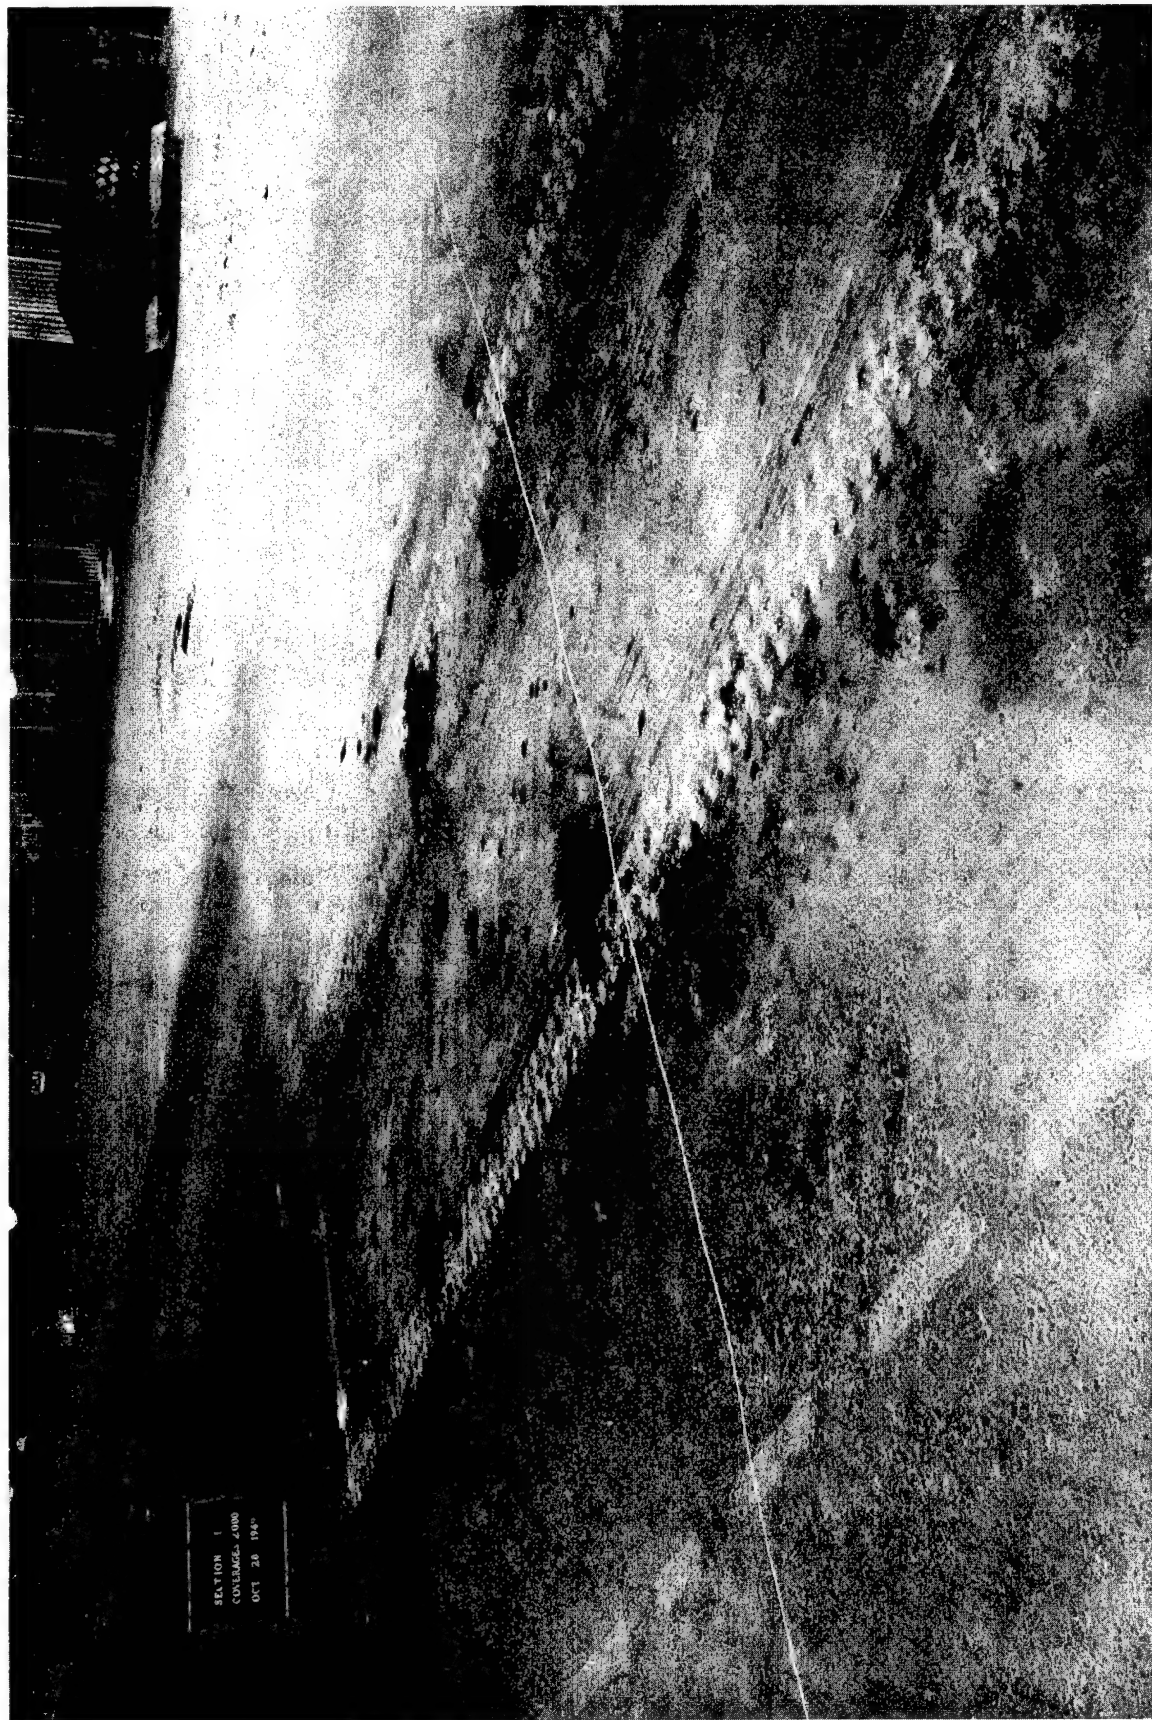
cent after 2,000 coverages (pit 26). An average CBR of 32 per cent is considered pertinent to this portion of the unit. The condition of the unit at the end of testing is shown in photograph 9.

Photograph 9. Unit 1, 14-in. thickness. View showing rutting after 2,000 coverages with 150,000-lb load on B-36 assembly

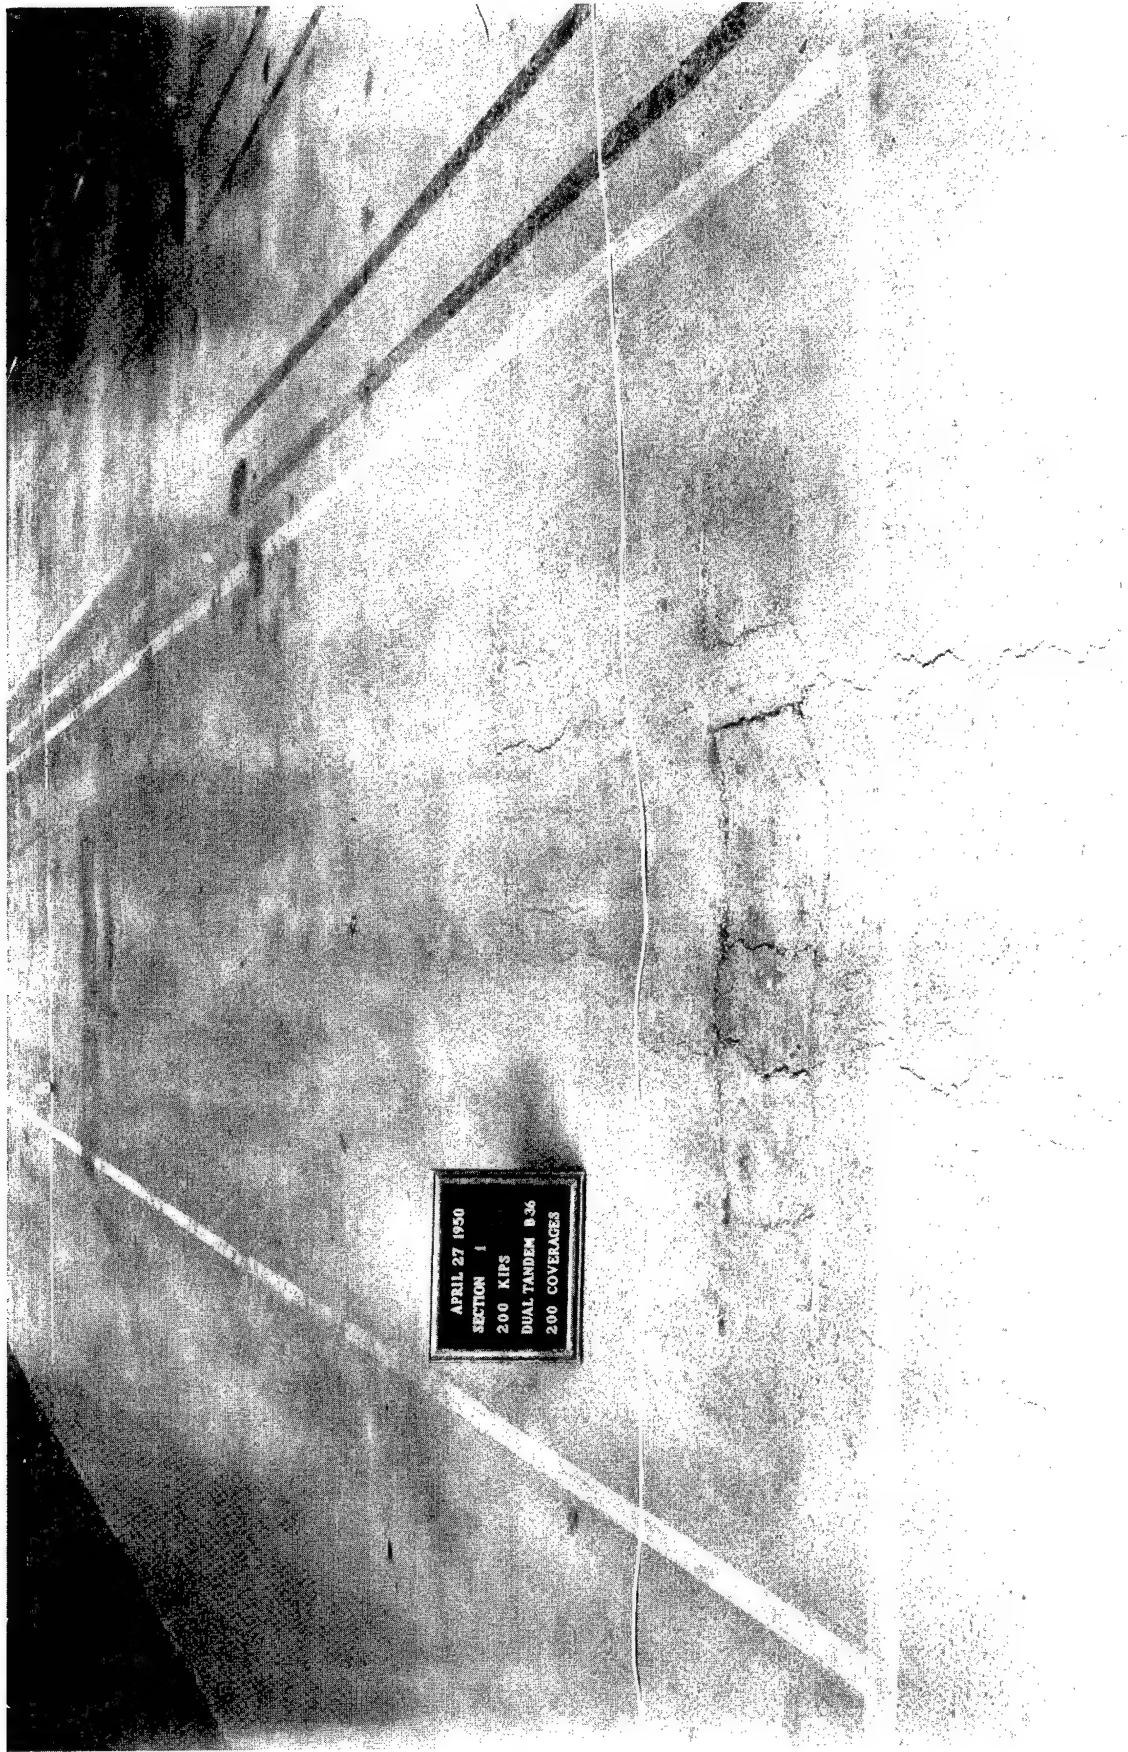
Unit 4 of the B-29 lane began to fail after 42 coverages of B-50 traffic and had completely failed after 328 coverages. The failure conditions in these units are shown in photographs 10, 11, 16, and 17. For convenience, the pertinent details of all test traffic are tabulated below:

Photograph 10. Unit 1, 14-in. thickness. View showing rutting and failure after 200 coverages with 200,000-lb load on B-36 assembly

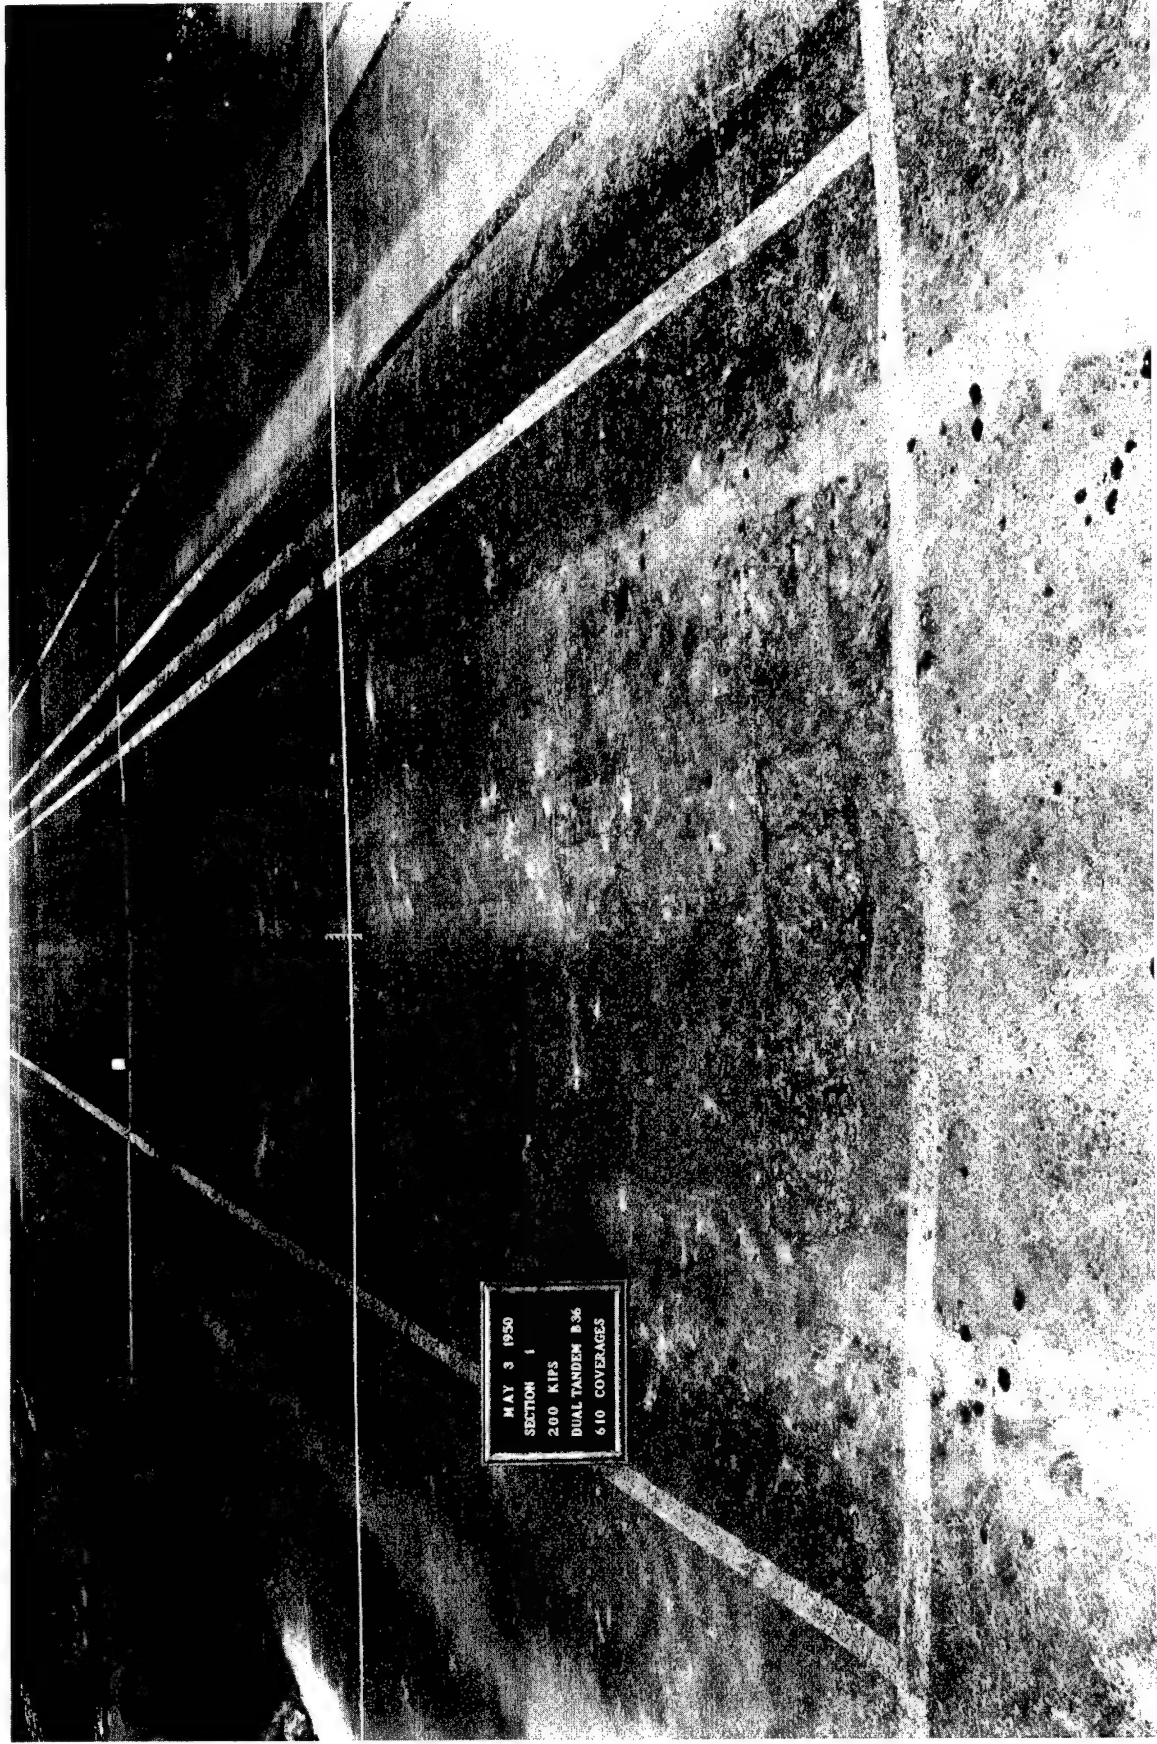
Photograph 11. Unit 1, 14-in. thickness. View after 610 coverages with 200,000-lb load on B-36 assembly

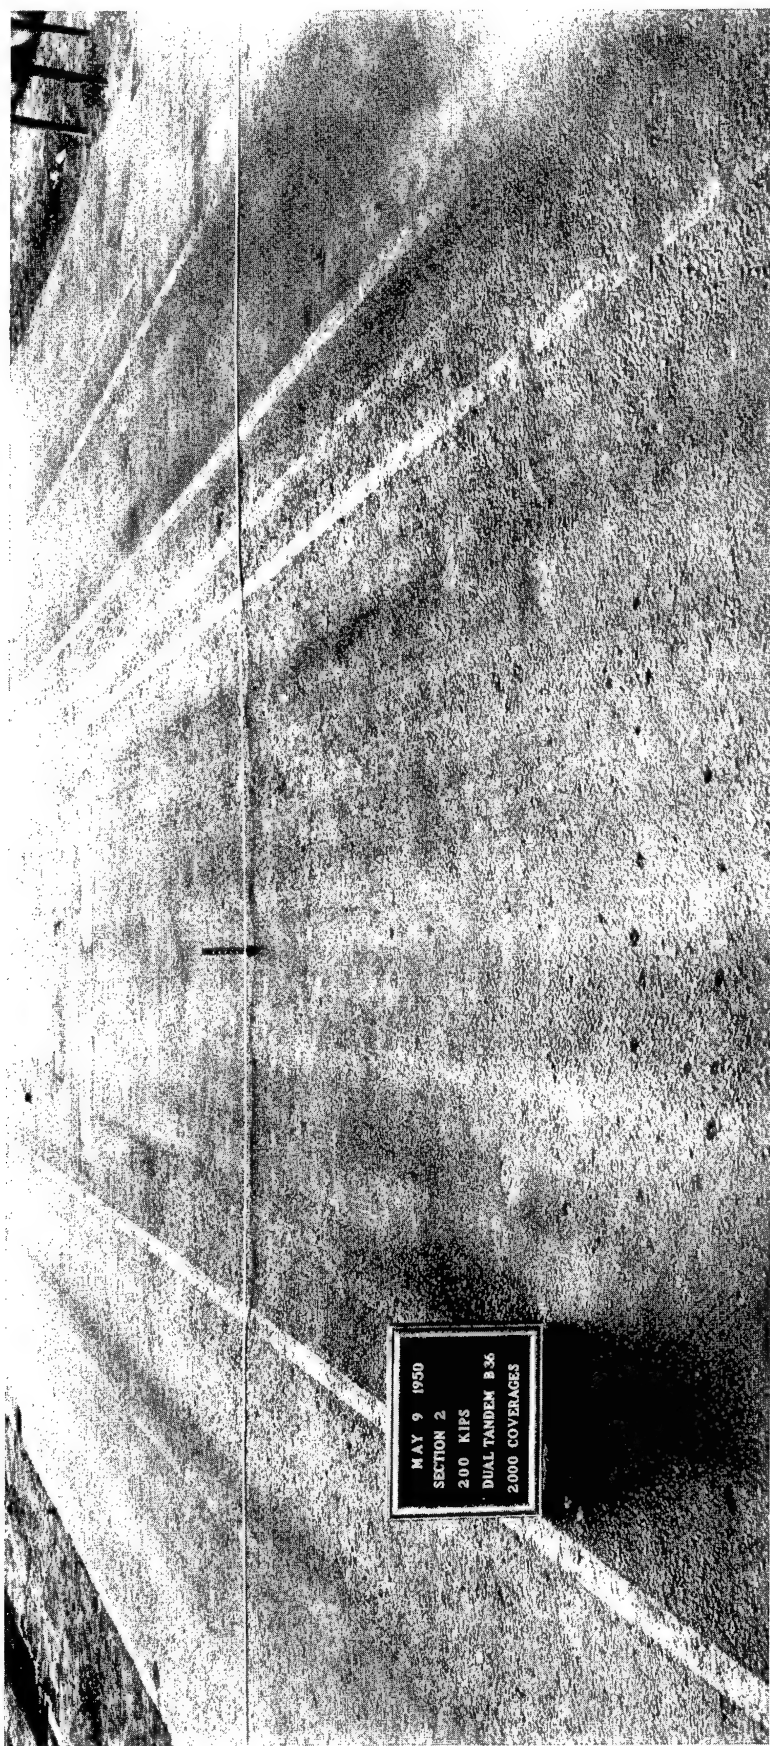
Photograph 12. Unit 2, 20-in. thickness. View showing rutting after 2,000 coverages with 200,000-lb load on B-36 assembly

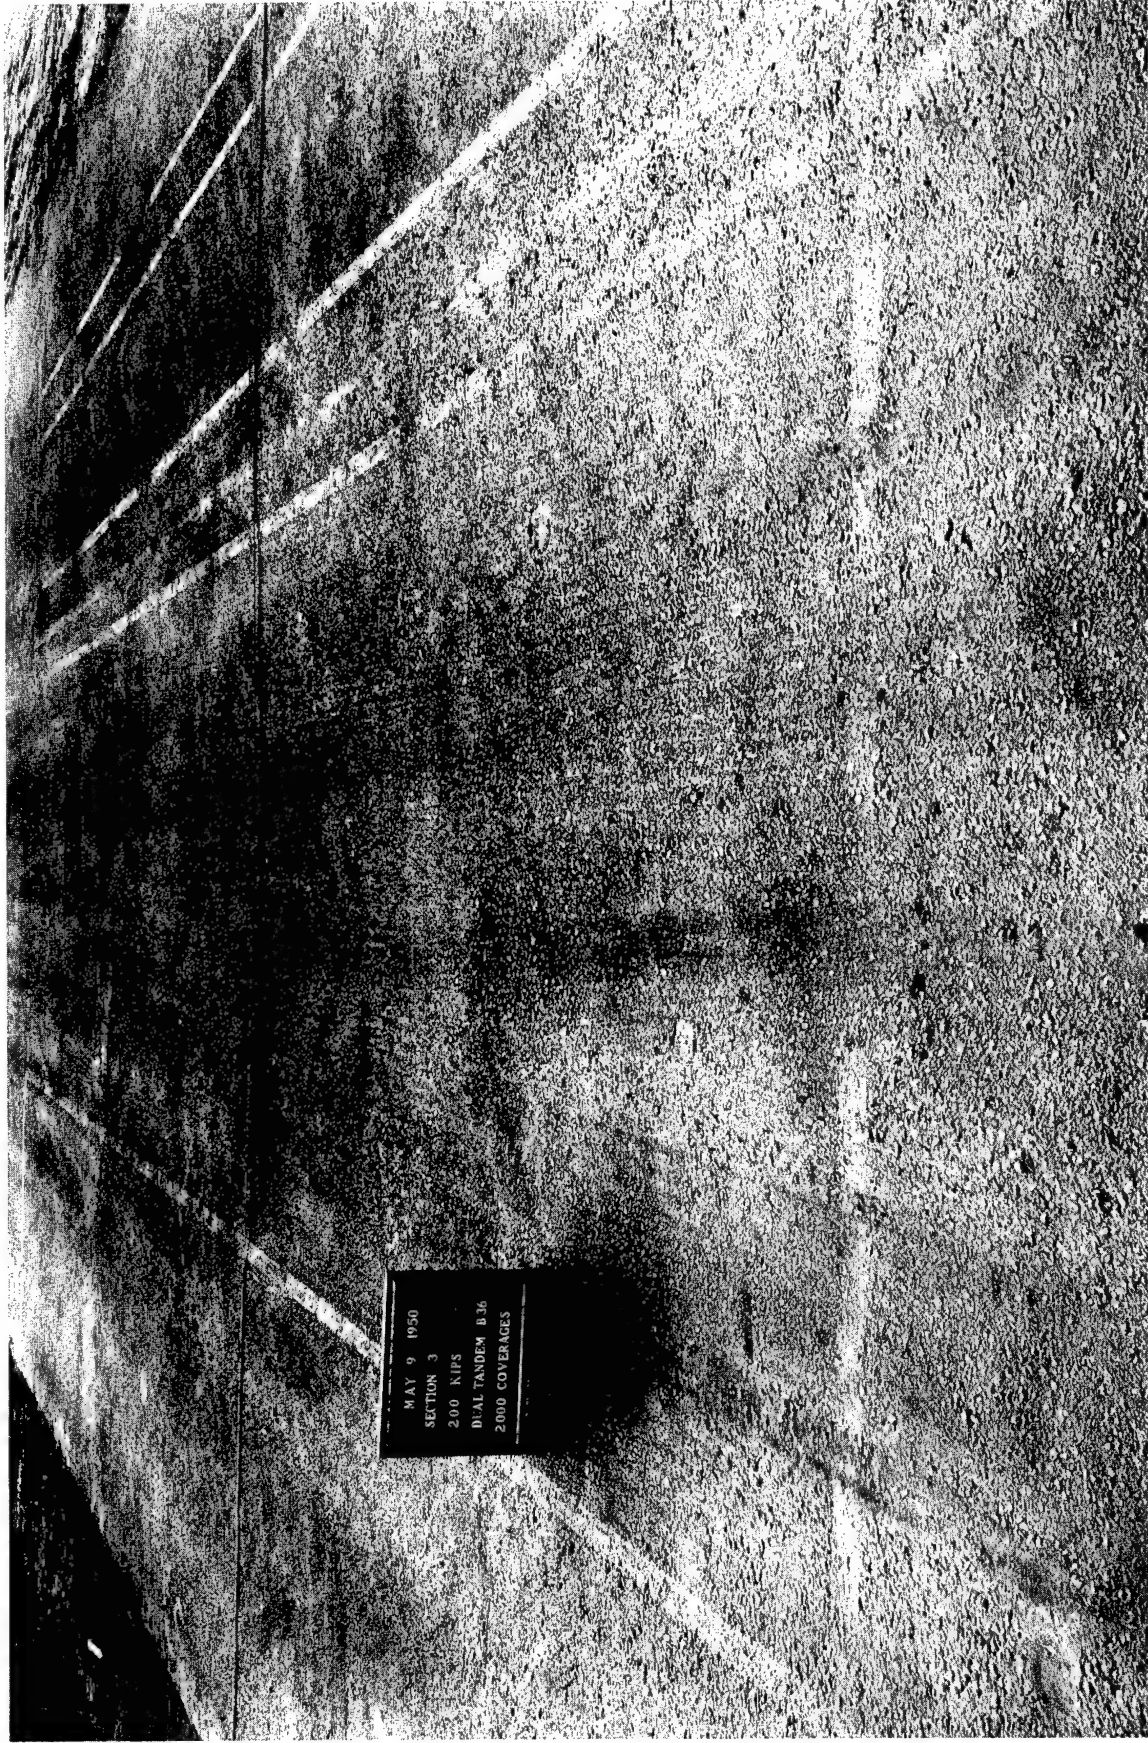
Photograph 13. Unit 3, 26-in. thickness. View after 2,000 coverages with 200,000-lb load on B-36 assembly

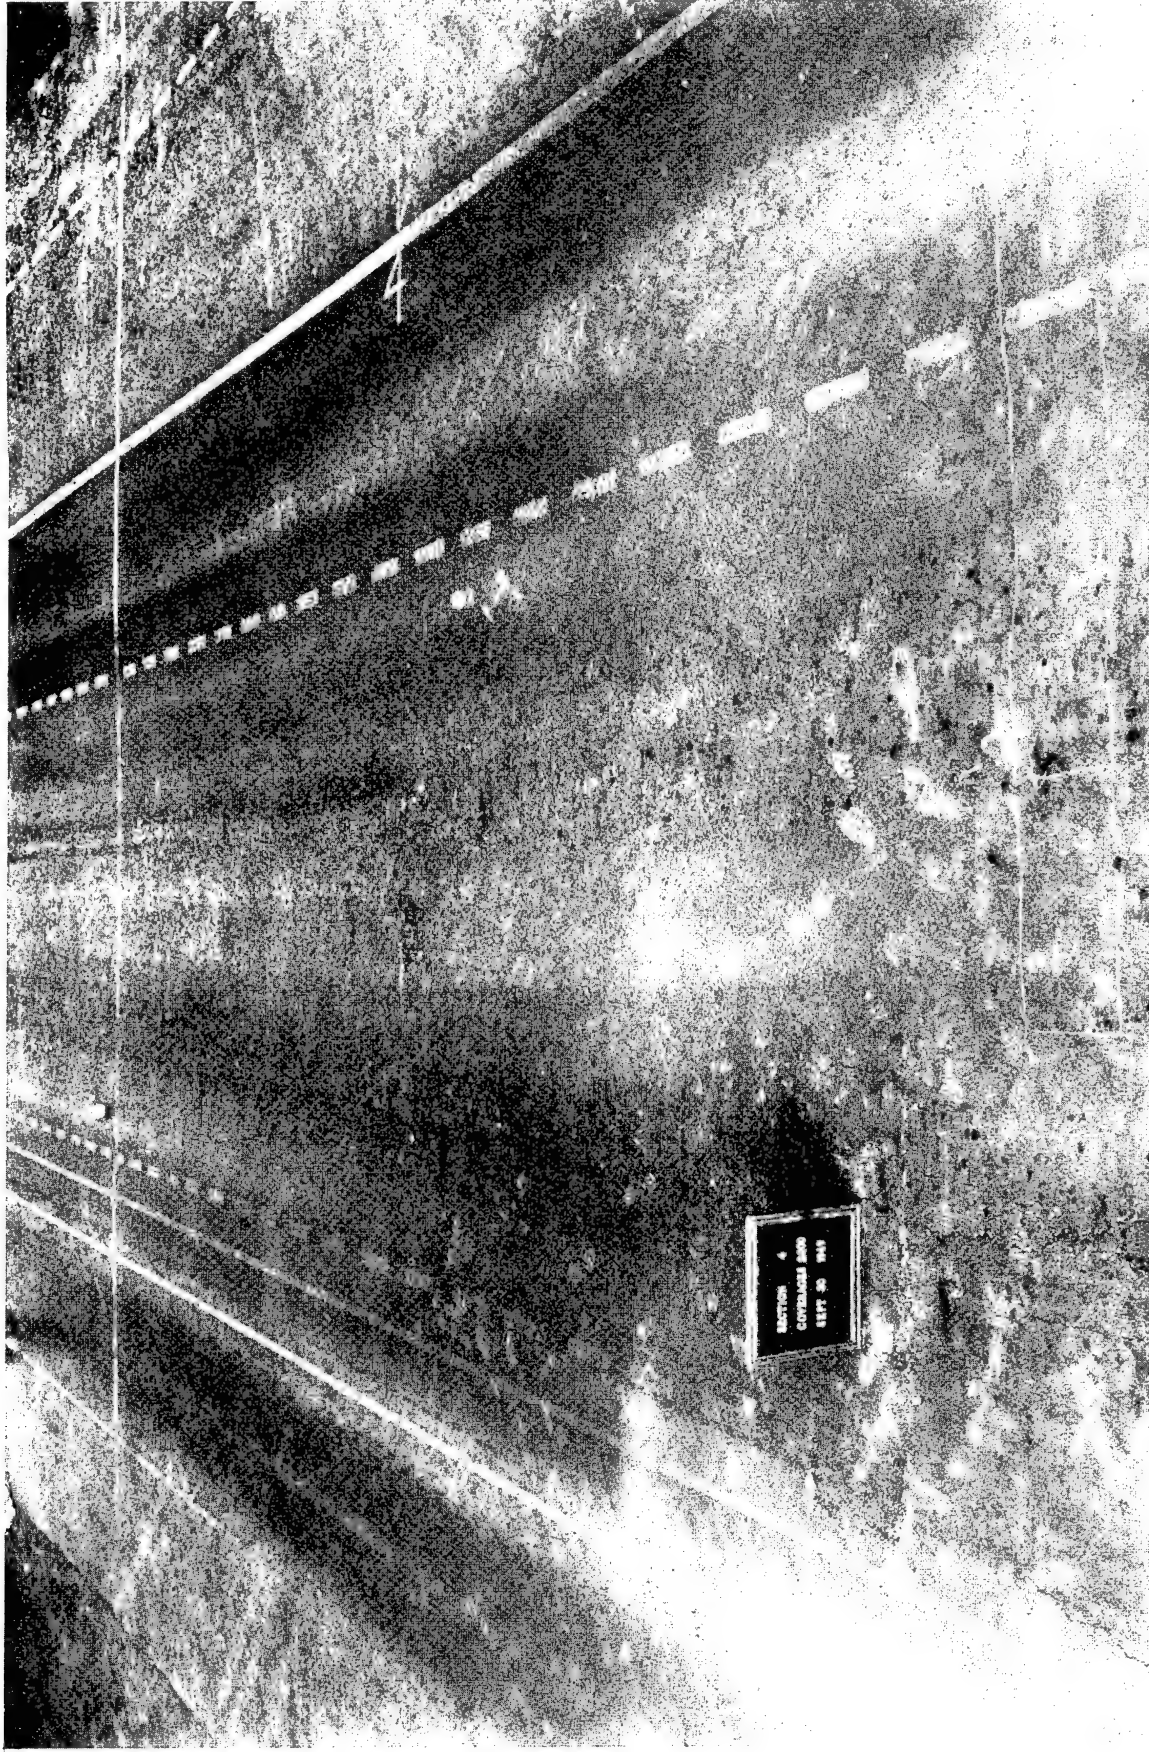
12. The first program of traffic produced failures in the south portion of the underdesigned units (units 1 and 4) in both lanes but the majority of the test section was in good condition at the end of this program (see photographs 9 and 14). Accordingly, a second program of traffic testing was applied to the test section with heavier loads. In the B-36 lane, traffic was applied with a B-36 assembly loaded to 200,000 lb and in the B-29 lane with a B-50 assembly loaded to 100,000 lb. Except for the underdesigned units 1 and 4, both lanes withstood this additional traffic without severe failure. Unit 1 of the B-36 lane began to fail after 210 coverages and had failed completely after 610 coverages.

Photograph 14. Unit 4, 10-in. thickness. View showing cracks after 2,000 coverages with 70,000-lb load on B-29 assembly

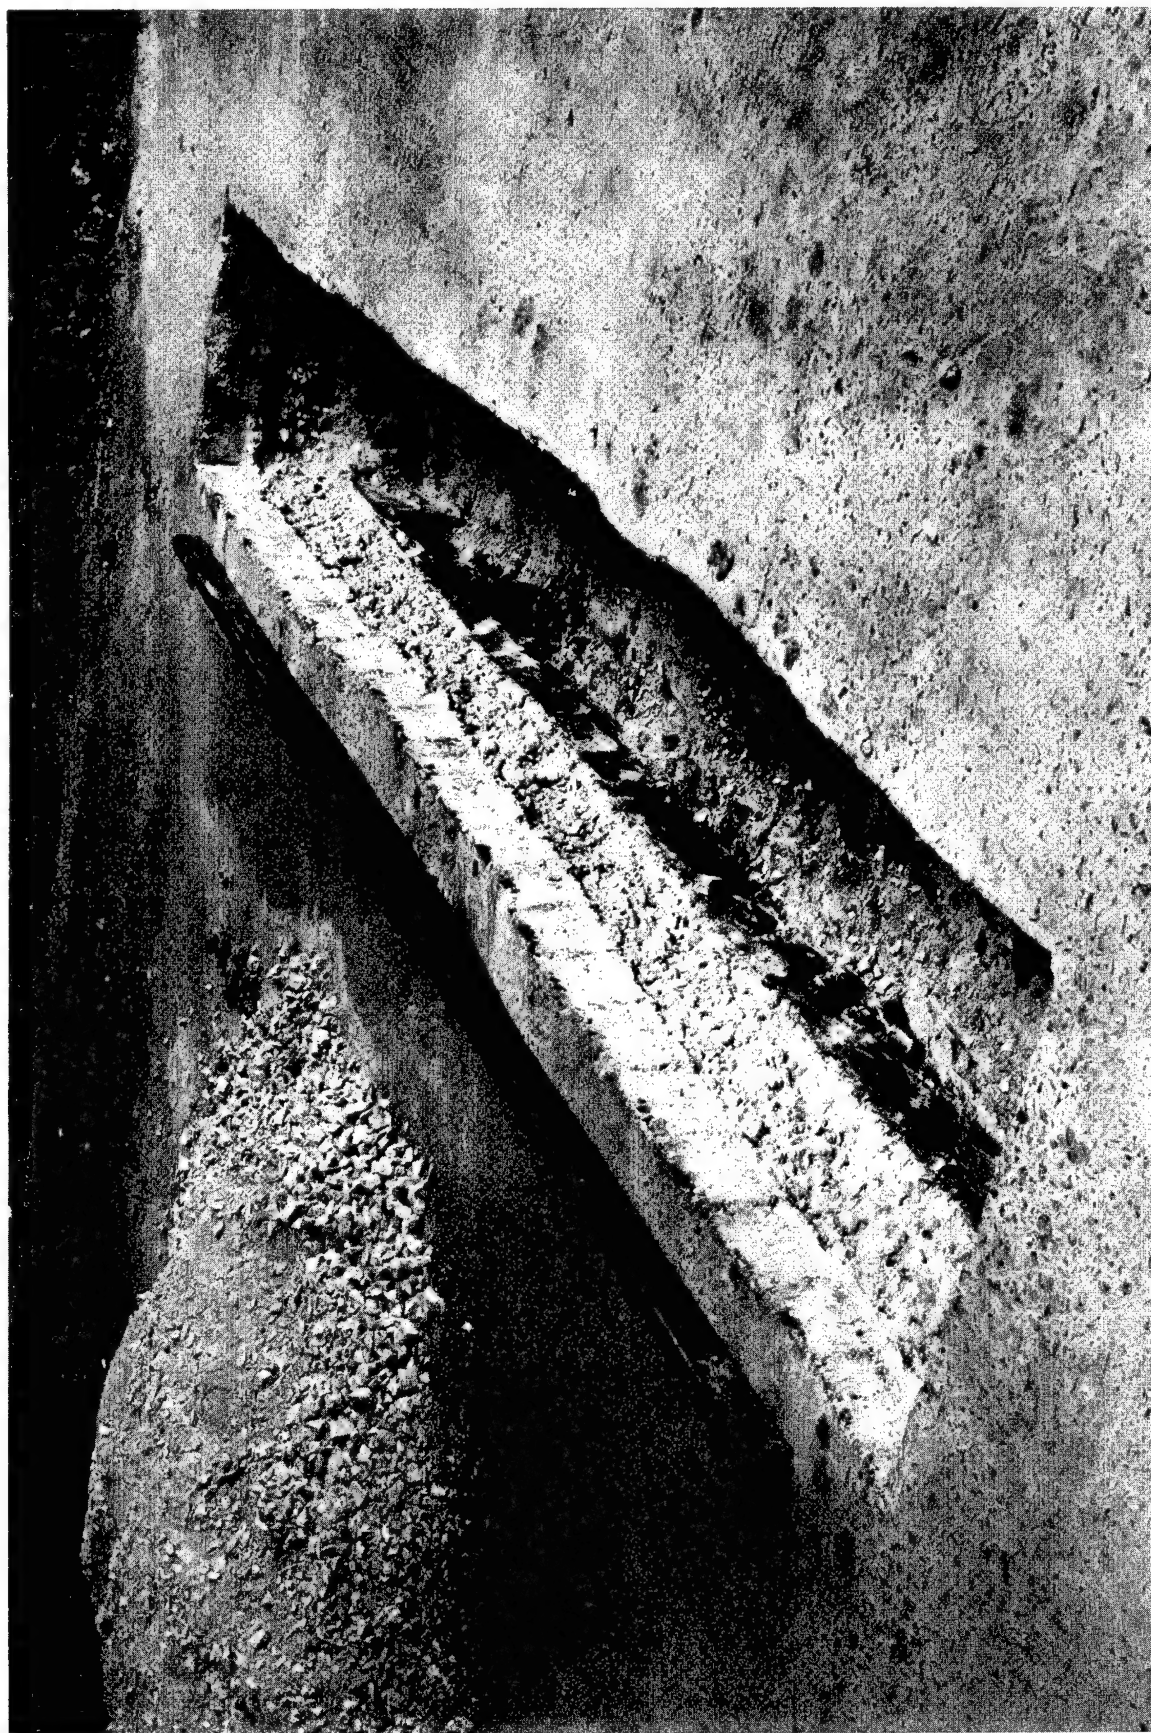
Photograph 15. Unit 4, 10-in. thickness. View of pit 4 after 2,000 coverages with 70,000-lb load on B-29 assembly

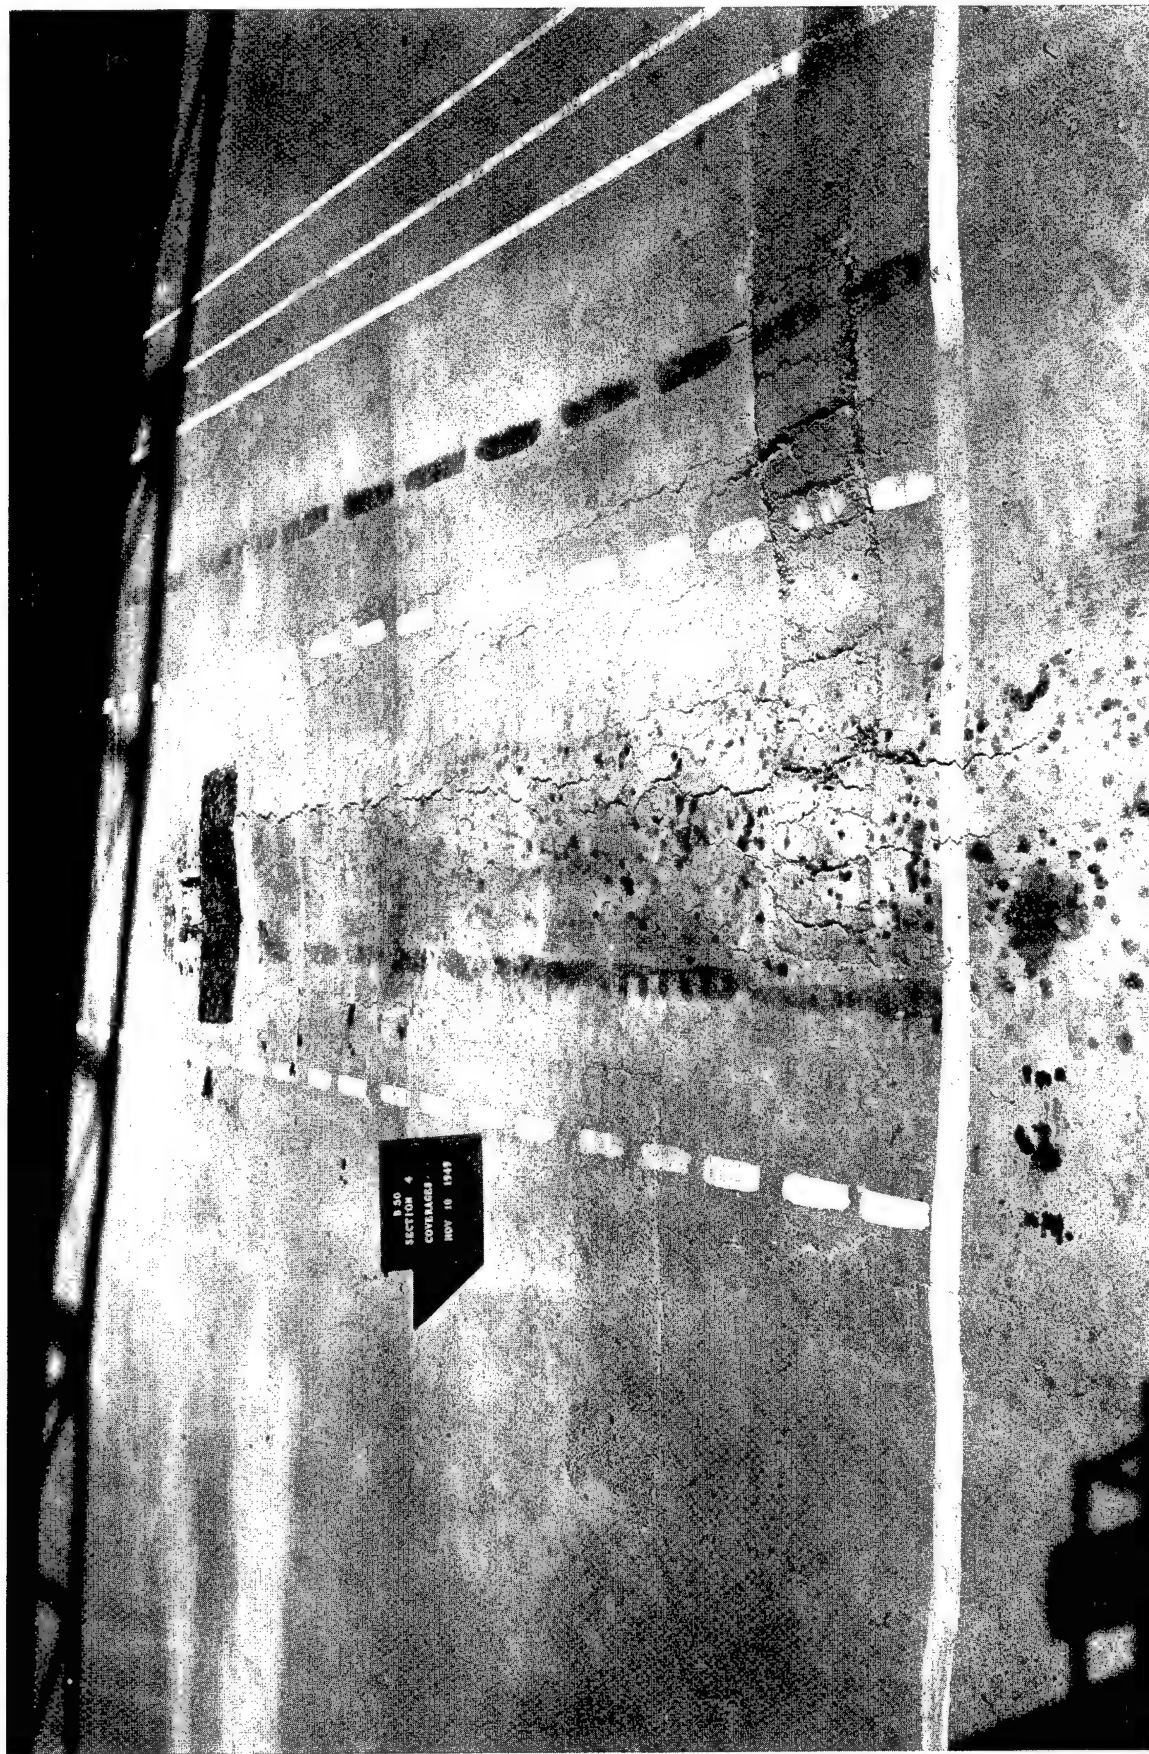
Photograph 16. Unit 4, 10-in. thickness. View showing condition of pavement after 42, 100, and 250 coverages with 100,000-lb load on B-50 assembly

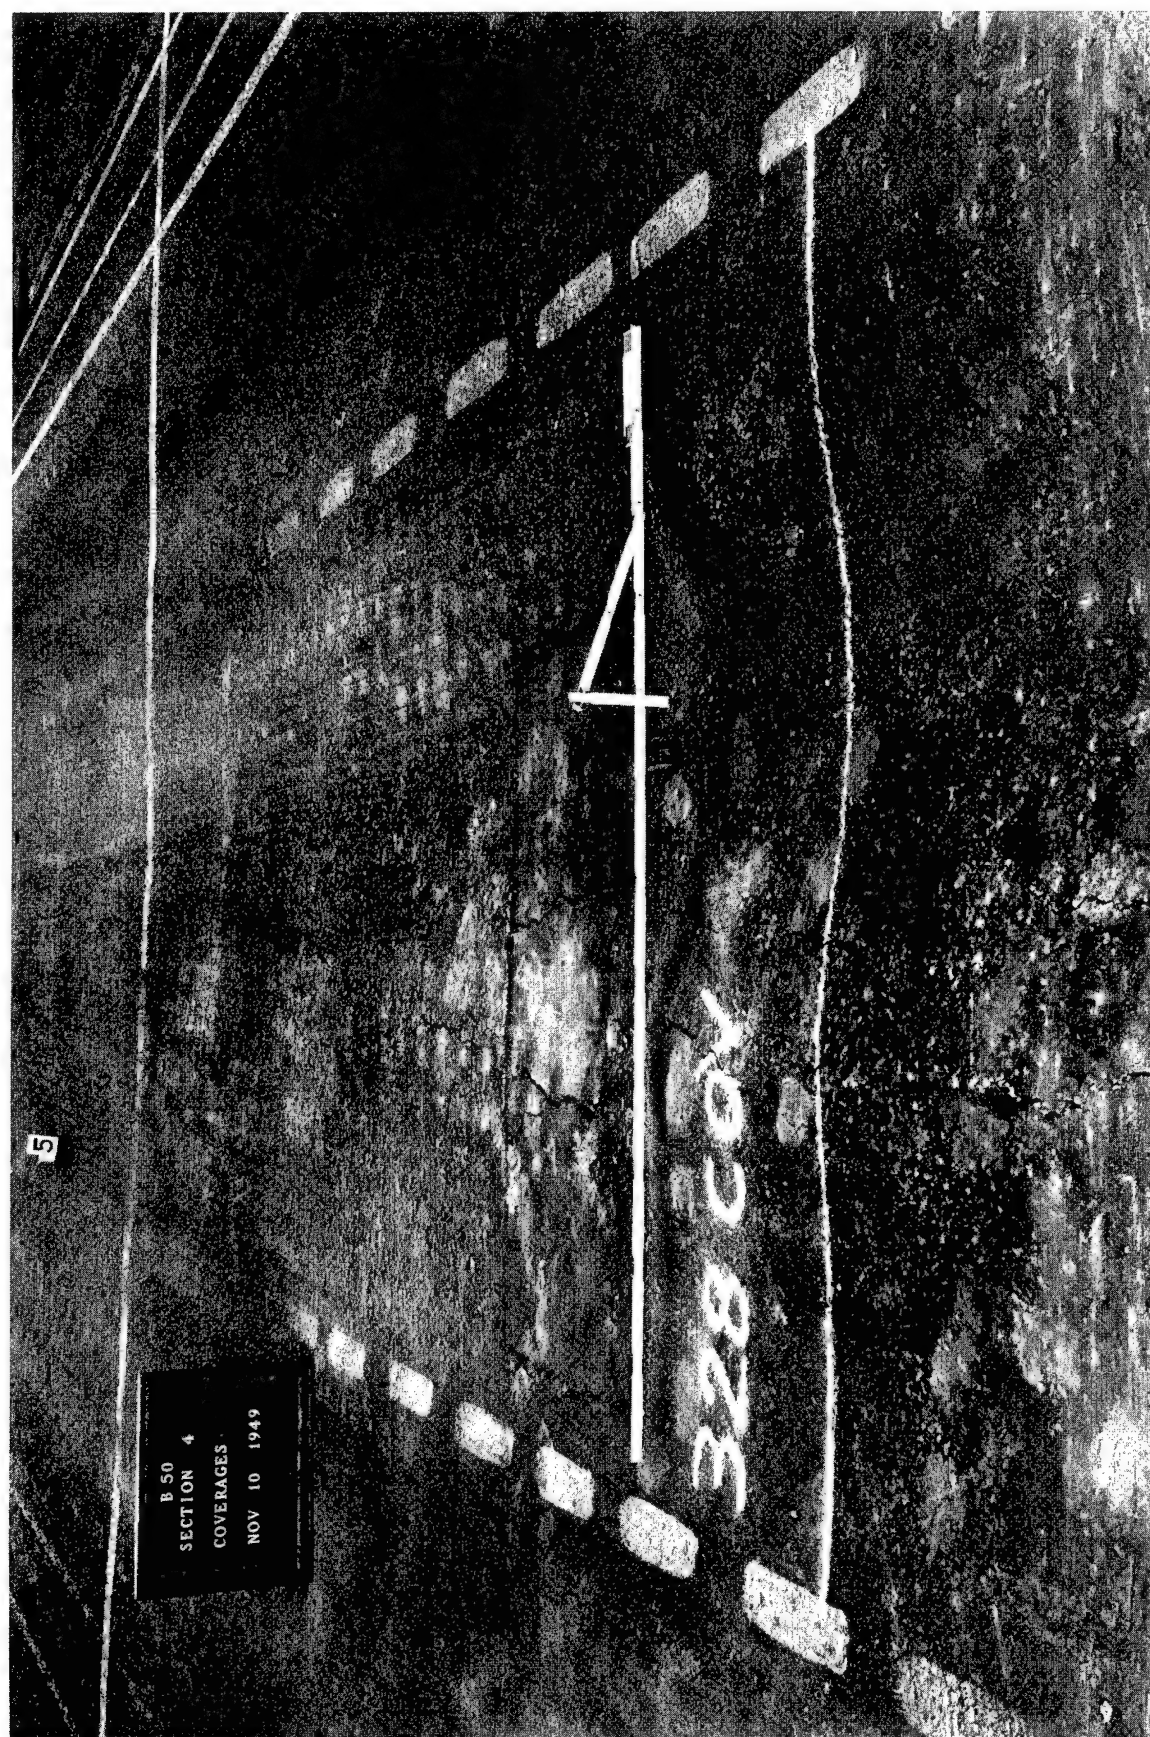
Photograph 17. Unit 4, 10-in. thickness. View showing condition of pavement after 328 coverages with 100,000-lb load on B-50 assembly

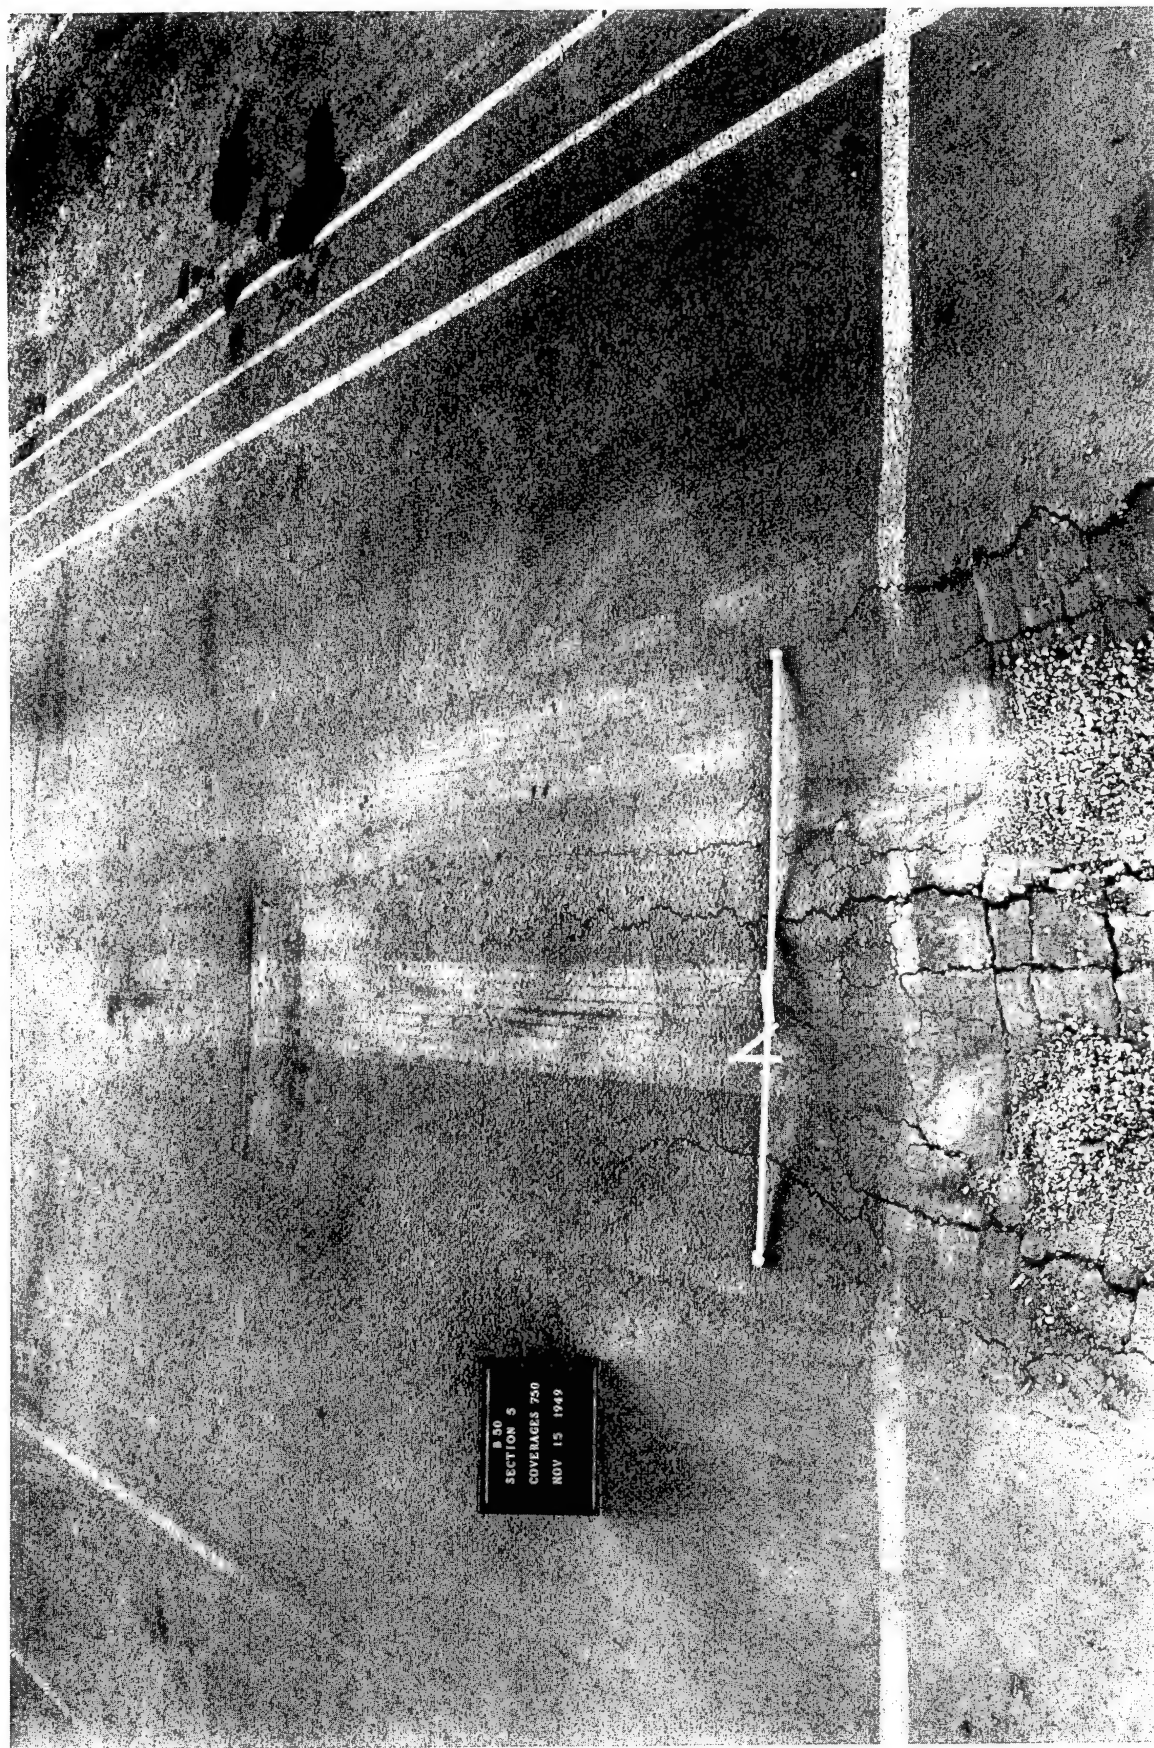
Photograph 18. Units 4 and 5, 10- and 15-in. thicknesses. View showing migration of cracks from 10- to 15-in. unit after 750 coverages with 100,000-lb load on B-50 assembly

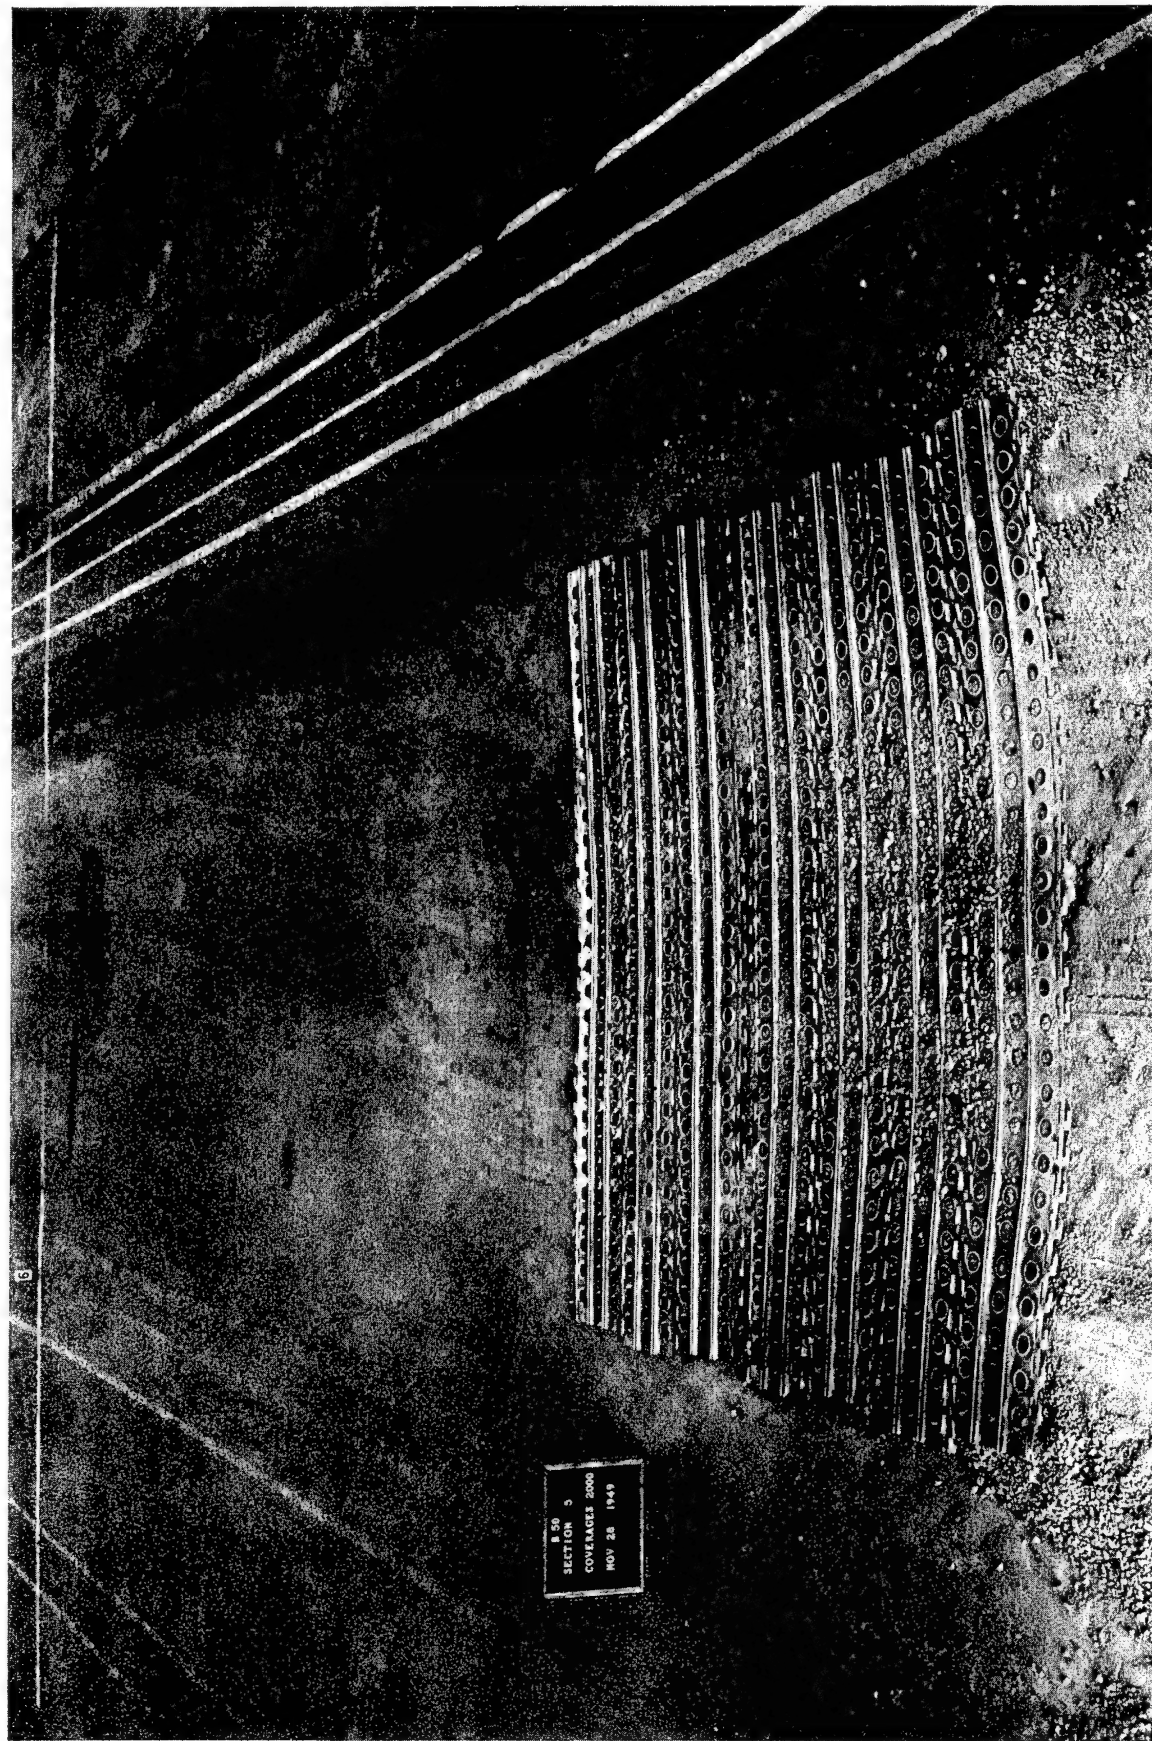
Photograph 19. Unit 5, 15-in. thickness. View showing condition of pavement after 2,000 coverages with 100,000-lb load on B-50 assembly
